OE QUALITY BRAKE HOSE ASSEMBLIES

VISUAL SIGNS IT'S TIME TO REPLACE BRAKE HOSES

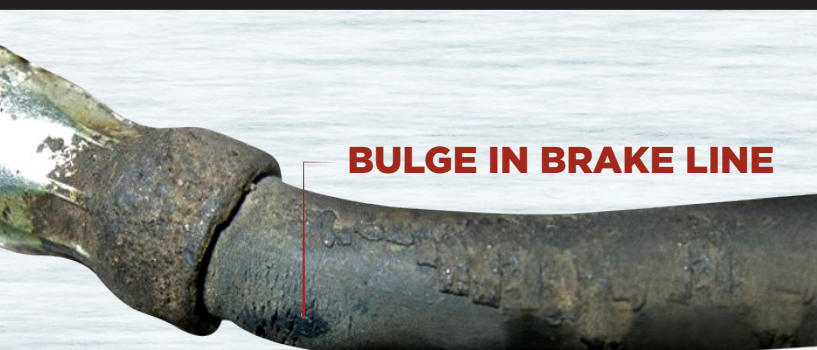
BULGE IN BRAKE LINE

1. Rubber hoses can degrade from exposure to the elements like UV rays, salt, road debris and ozone.
2. Brake fluid absorbs water over-time and can rust the inside of the tubing. This may not be visible until a leak develops.
3. Heat and moisture can weaken rubber at points connecting to the line. A crack in the hose inner lining can lead to visible leaking/seepage.

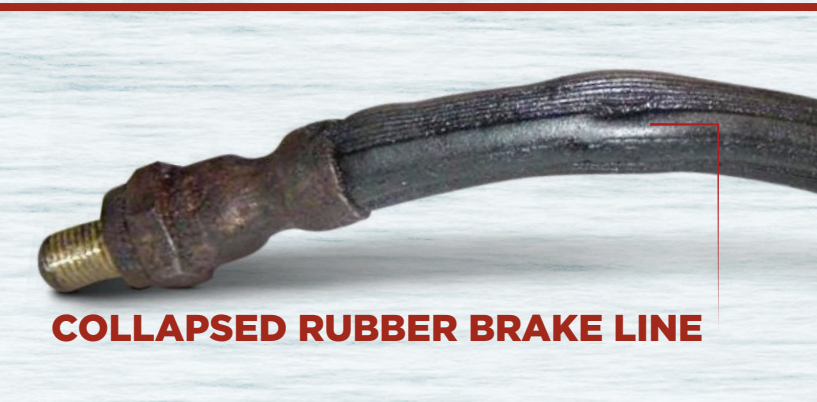
COLLAPSED RUBBER BRAKE LINE

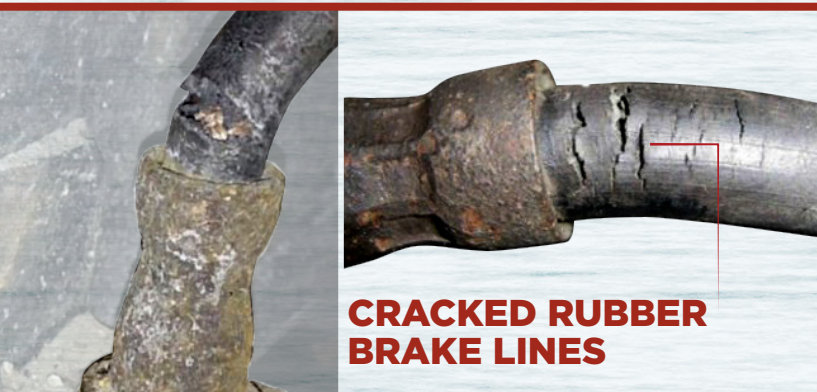
CRACKED RUBBER BRAKE LINES
